SANSUI AU- $\alpha$  205

故障内容 ノイズ、異音がする、セレクターの接点接触不良

修理内容 セレクタースイッチの接点改善、パワーアンプ入力側のコンデンサー交換  
(漏電のためノイズが出るため)

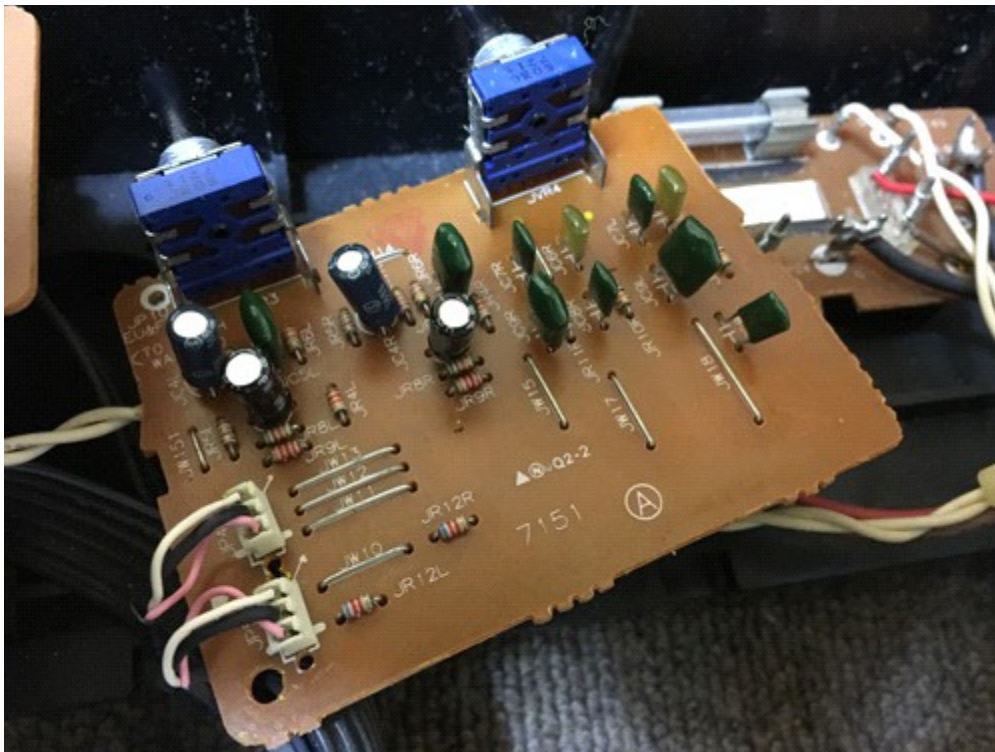
## 漏電のためトーン回路を調べる

This image shows the internal components of a power supply unit. The main brown printed circuit board (PCB) is populated with various electronic components, including electrolytic capacitors, resistors, and integrated circuits. A large black transformer is visible on the left side. A green daughterboard is connected to the main PCB. The unit is housed in a metal enclosure with a black fan cover on the right side.
